December 5, 2016

Re: Petersen Ranch Mitigation Bank Elizabeth Lake Area E As-built Report [USACE File No: SPL-2012-00669-BEM, CDFW Tracking No: 1600-2015-0075-R5]

PETERSEN RANCH MITIGATION BANK AREA E AS-BUILT SET L-SC INTERIOR FENCE DETAILS

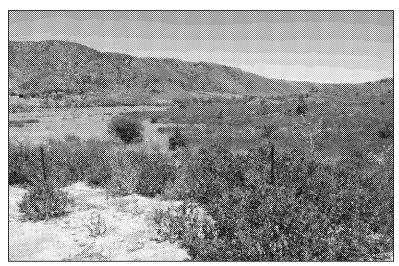
CPP-1 looking northeast on July 18, 2016

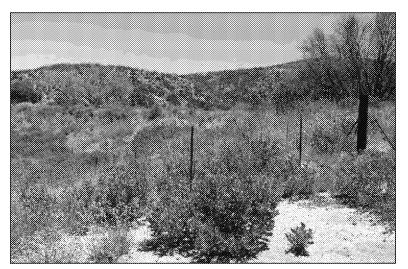
CPP-1 looking southeast on July 18, 2016

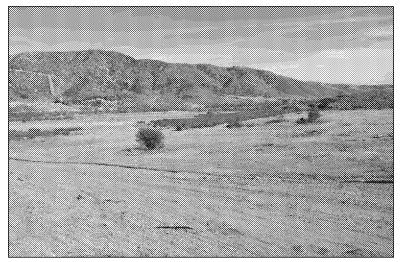
CPP-1 looking northeast on November 16, 2016

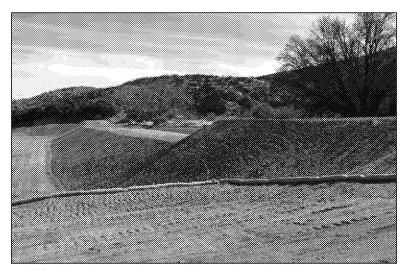
CPP-1 looking southeast on November 16, 2016

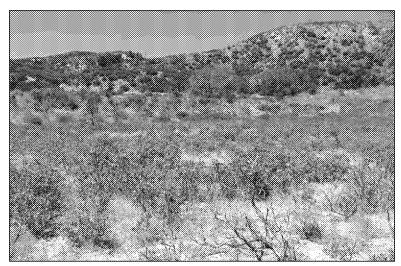
CPP-2 looking west on July 19, 2016

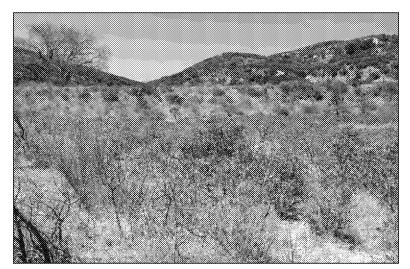
CPP-2 looking south on July 19, 2016

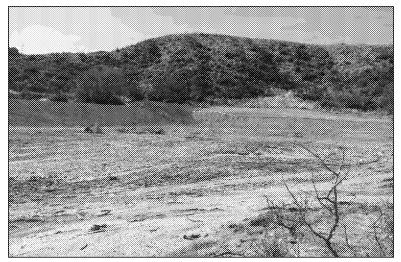
CPP-2 looking west on November 16, 2016

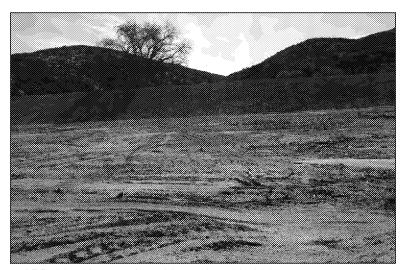
CPP-2 looking south on November 16, 2016

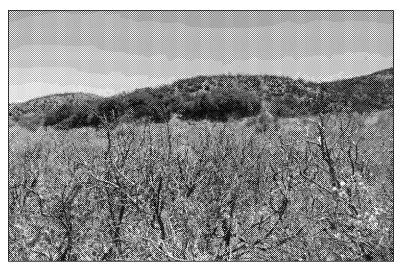
CPP-2 looking east on July 18, 2016

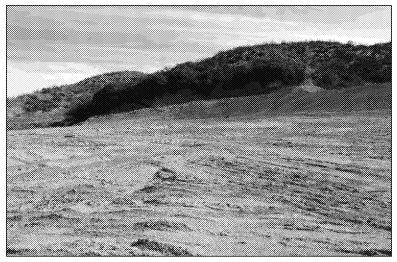
CPP-2, looking east on November 16, 2016

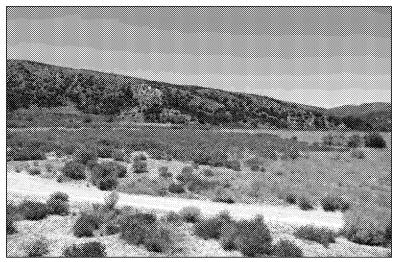
CPP-3 looking northwest on July 18, 2016

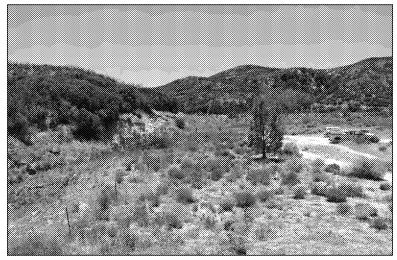
CPP-3 looking southwest on July 18, 2016

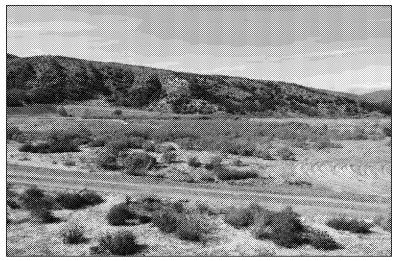
CPP-3 looking northwest on November 16, 2016

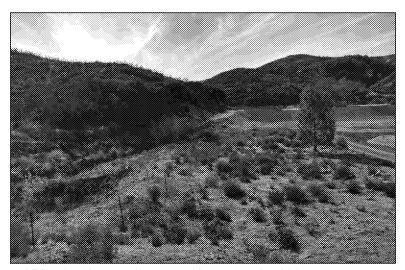
CPP-3 looking southwest on November 16, 2016

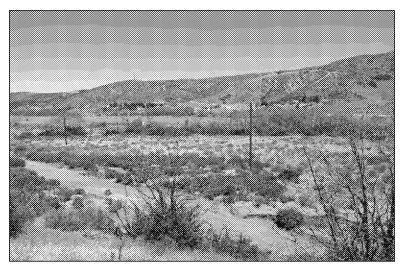
CPP-4 looking northwest on July 19, 2016

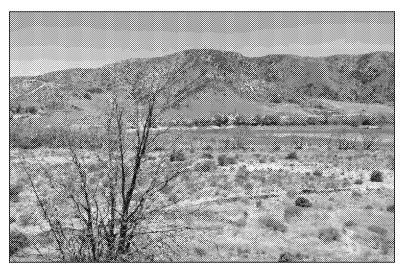
CPP-4 looking northeast on July 19, 2016

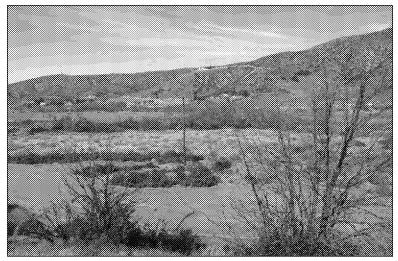
CPP-4 looking northwest on November 16, 2016

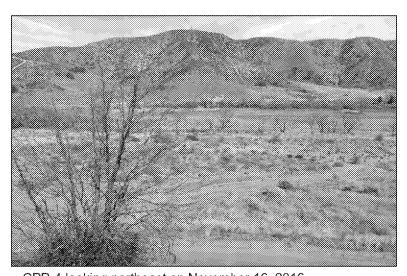
CPP-4 looking northeast on November 16, 2016

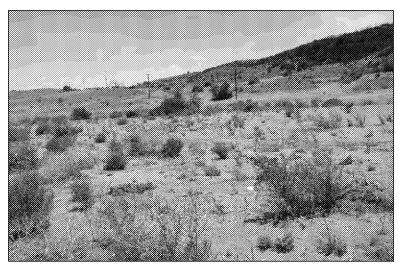
CPP-5 looking east on July 26, 2016

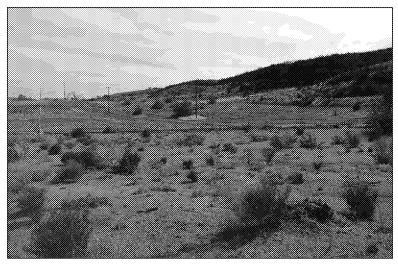
CPP-5 looking east on November 16, 2016
